Monitored Natural Attenuation Engineering Demonstration Project

Summary Report

*Lemberger Landfill and Lemberger Transport and Recycling Site
Franklin Township, Manitowoc County, Wisconsin*

December 2008

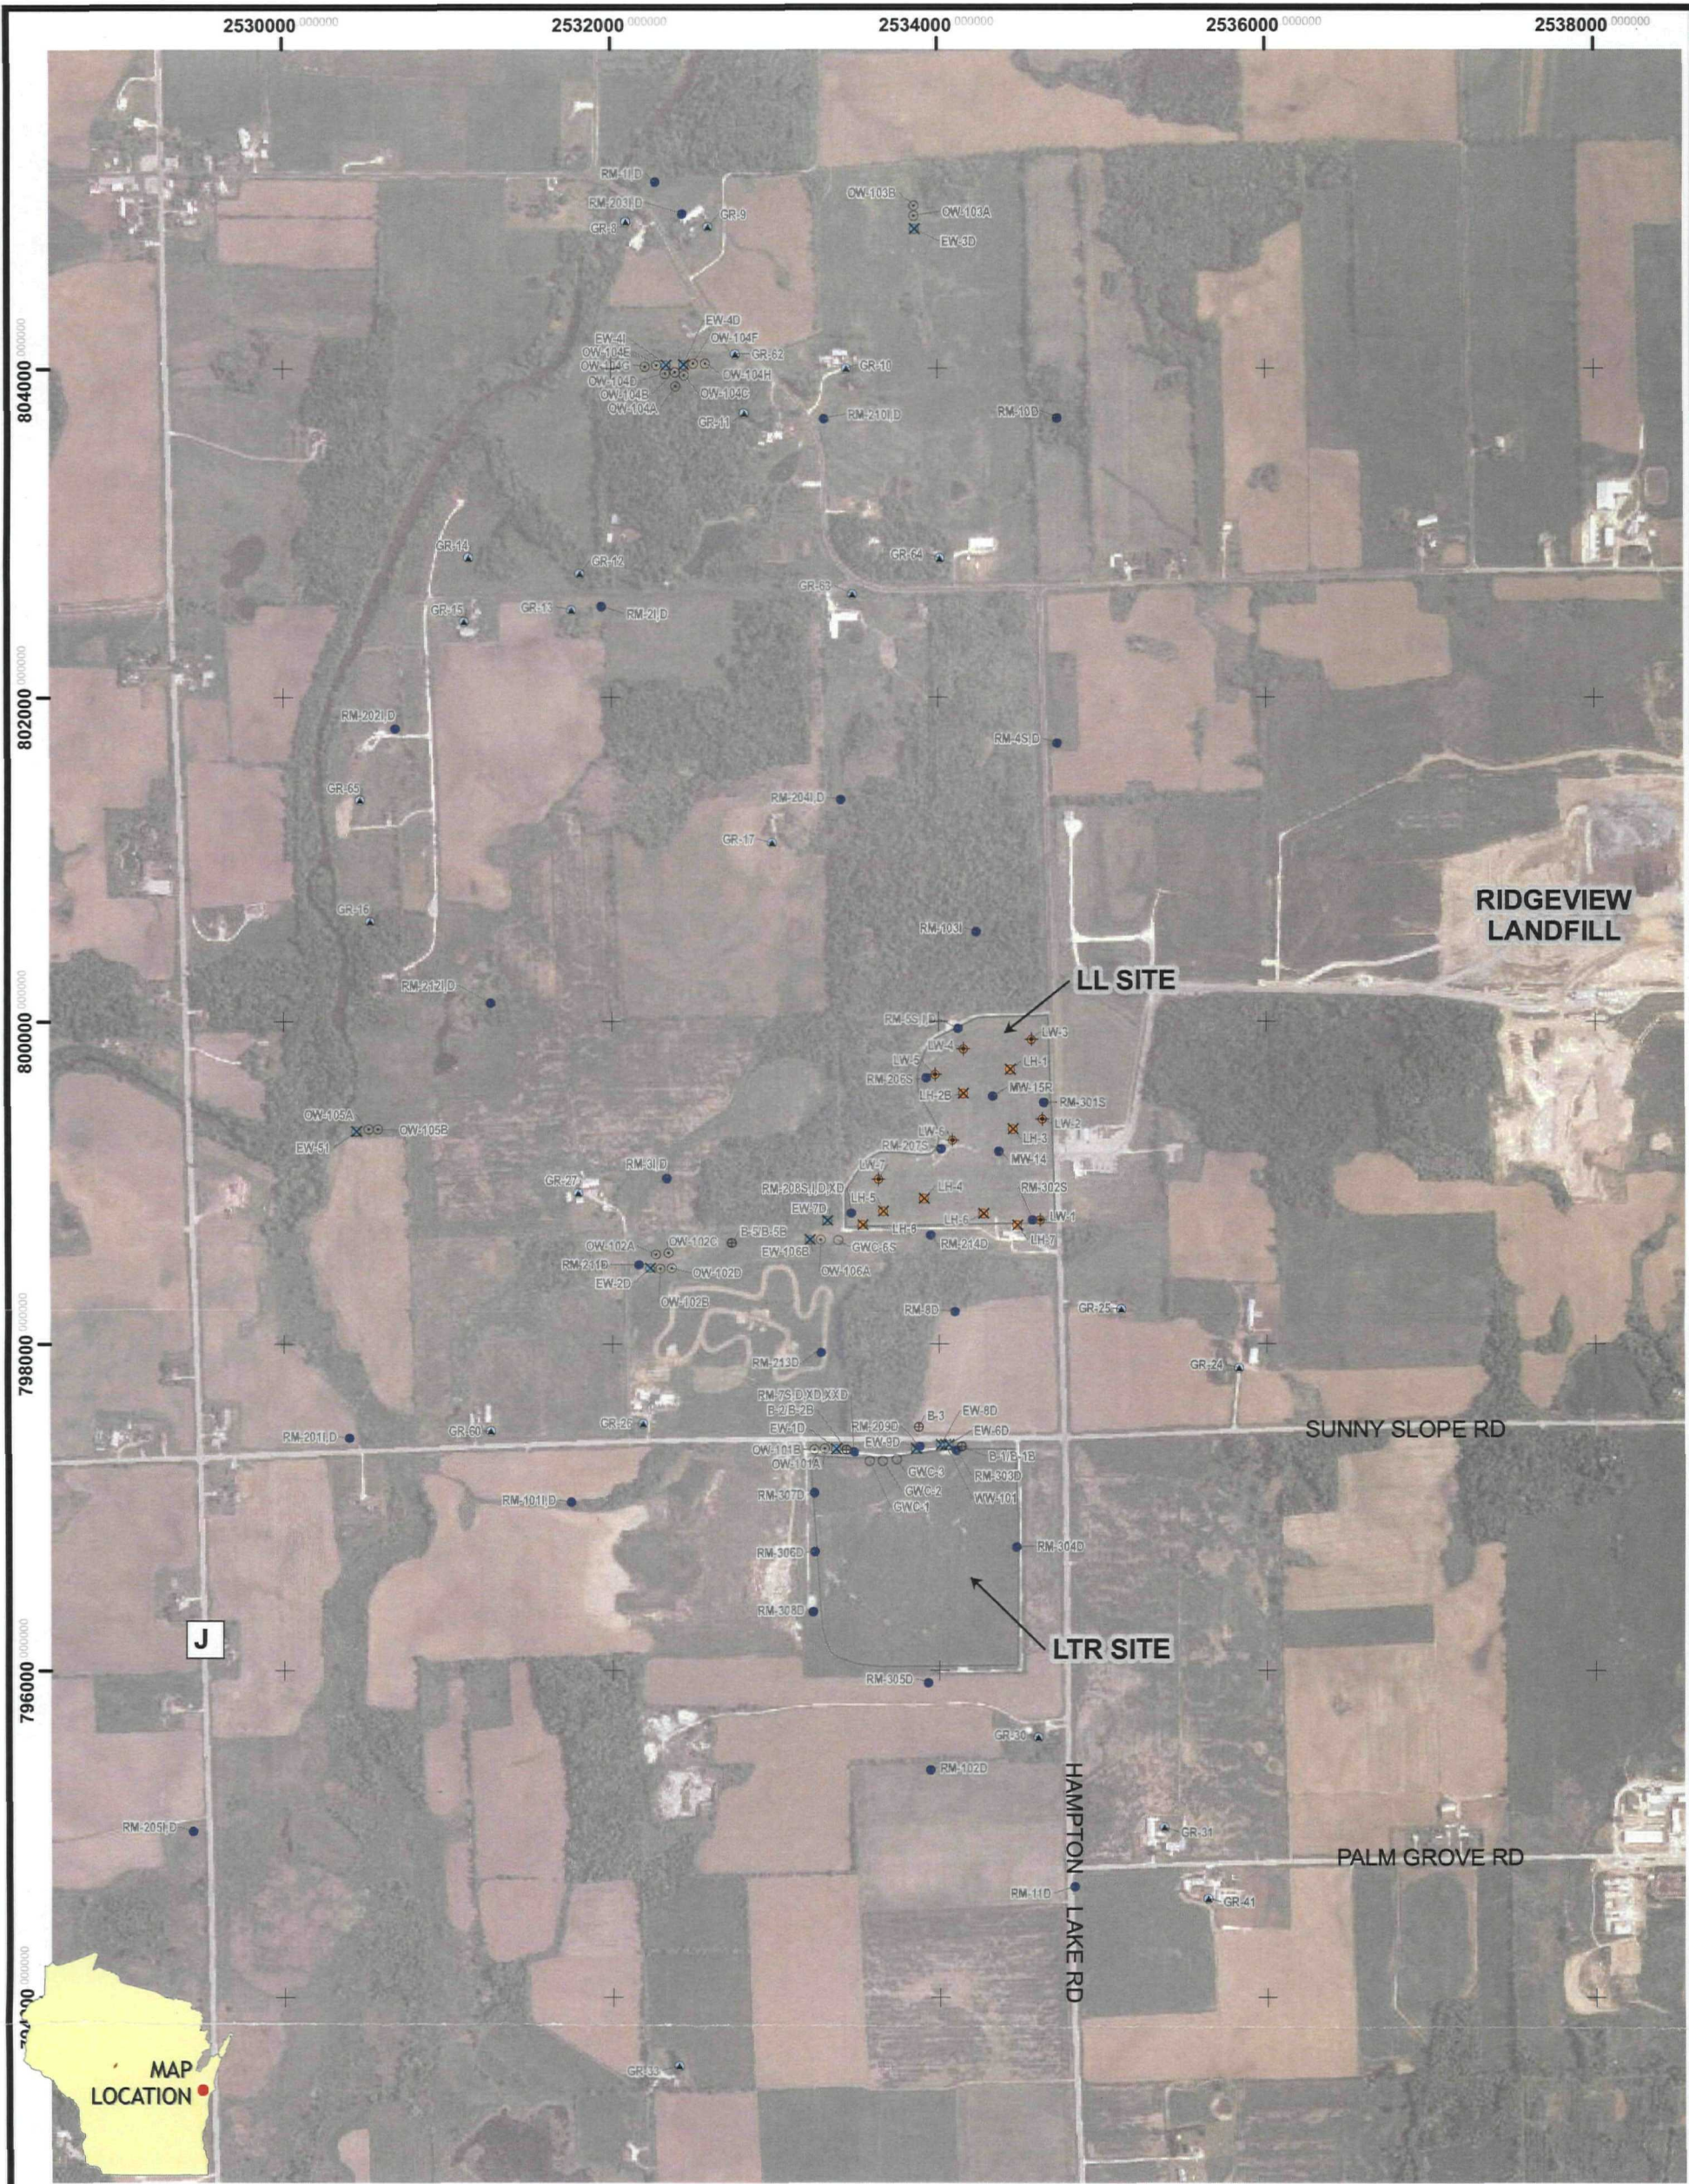
PROJECT: LEMBERGER LANDFILL AND LEMBERGER TRANSPORT AND RECYCLING SITES			
TOWN OF FRANKLIN, WISCONSIN			
SHEET TITLE: MNA DEMONSTRATION PROJECT			
SITE PLAN SHOWING ALL MONITORING POINTS			
DRAWN BY: HANKLEY C	SCALE: AS NOTED	PROJ. NO. 00-03457.46	FIGURE 1
CHECKED BY: THC	DATE PRINTED: 12/22/2008	FILE NO. 34574601.mxd	
APPROVED BY: JDW			
DATE: DECEMBER 2008			
RMT			
744 Heartland Trail Madison, WI 53717-1934 P.O. Box 8923 53708-8923 Phone: 608-831-4444 Fax: 608-831-3334

The LSRG submits the following Long-Term MNA Sampling Program to accommodate future amendment of the ROD. Table 10 presents the proposed Long-Term MNA Sampling Program. Refer to Figure 1 for the well locations. The proposed Long-Term MNA Monitoring Program is recommended to be implemented upon completion of and EPA approval of the results of the LL Leachate Head Study. Until that time, the Interim Groundwater Monitoring Program, which was approved by the USEPA and WDNR on December 17, 2008, will be implemented.
